# Manhole Inspection Summary

Manhole # S29G\_\_002MH

Insp Date: **8/4/08 10:28 AM**

**Location** Address: **655 w baltimore st**

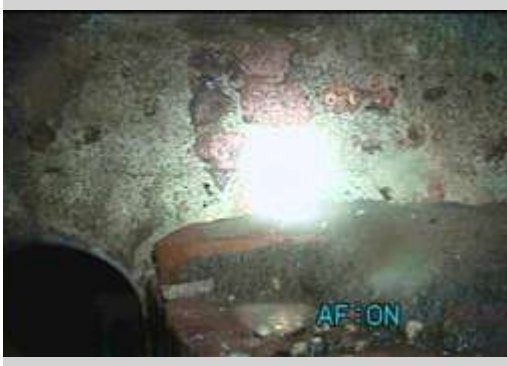
Defect 5

Condition: ☐ Sound ☐ Cracked ☐ Root Intrusion ☐ Deteriorated ☐ Leaks ☒ **Debris**

bench debris

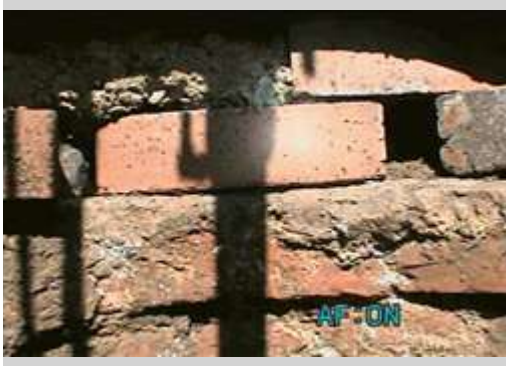
Defect 3

Condition: ☐ Sound ☐ Cracked ☐ Root Intrusion ☒ **Loose Brick** ☒ **Deteriorated**

frame adj

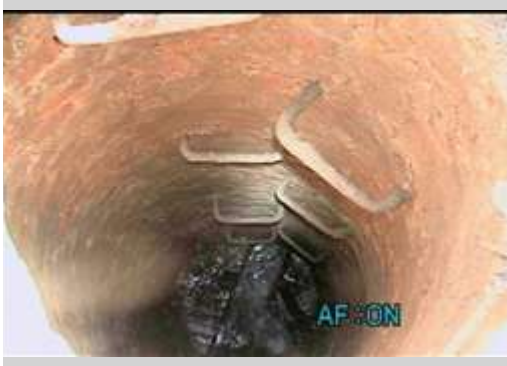
Defect 2

Count: **7** Missing: **0** ☒ **Corroded**

steps

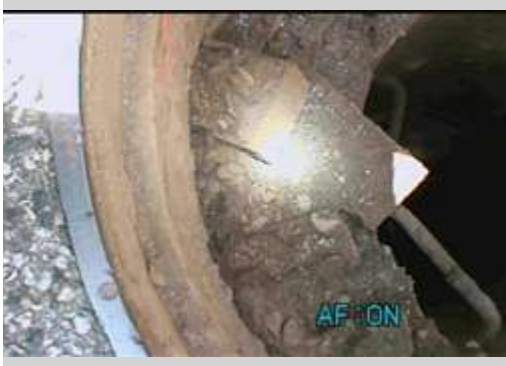
Defect 1

Offset: **8** (in.)

Condition: ☐ Sound ☒ **Cracked** ☐ Leaks

offset
